**Any active Alternate Feed System that has not been approved by DES
Will Result in Immediate Disconnection of Electric Service**

3 **One Line Diagram**

Solar Install

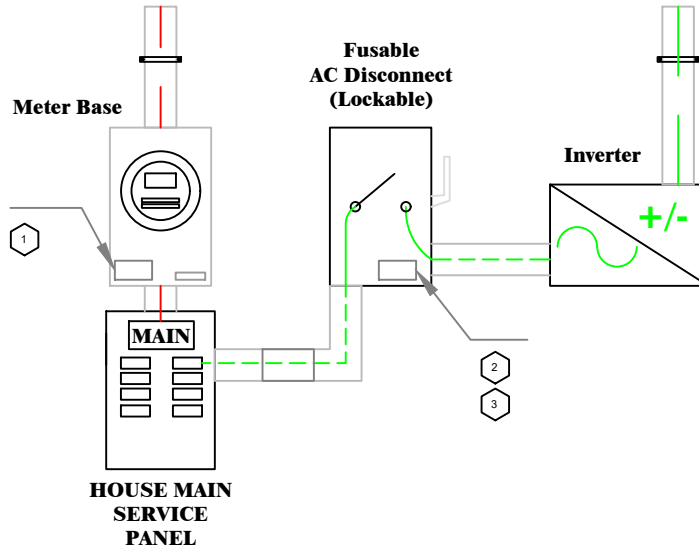
FIGURE NO:
1S

1 **!WARNING!**
SERVICE IS EQUIPPED WITH AN
ALTERNATE POWER SOURCE

2 **DES DISCONNECT**

1. **This diagram shows a typical installation and does not include all PV system components. Grounding connections are not shown for simplicity.**
2. **All PV components shall be in compliance with the corresponding NEC and IEEE codes.**
